## ENVIRONMENTAL TESTS ON WS133B TECHNICAL FACILITIES PERSONNEL ACCESS HATCH

TECHNICAL REPORT NO. AFSWC-TR-65-3

AIR FORCE SPECIAL WEAPONS CENTER  
Air Force Systems Command  
Kirtland Air Force Base  
New Mexico

January 1966

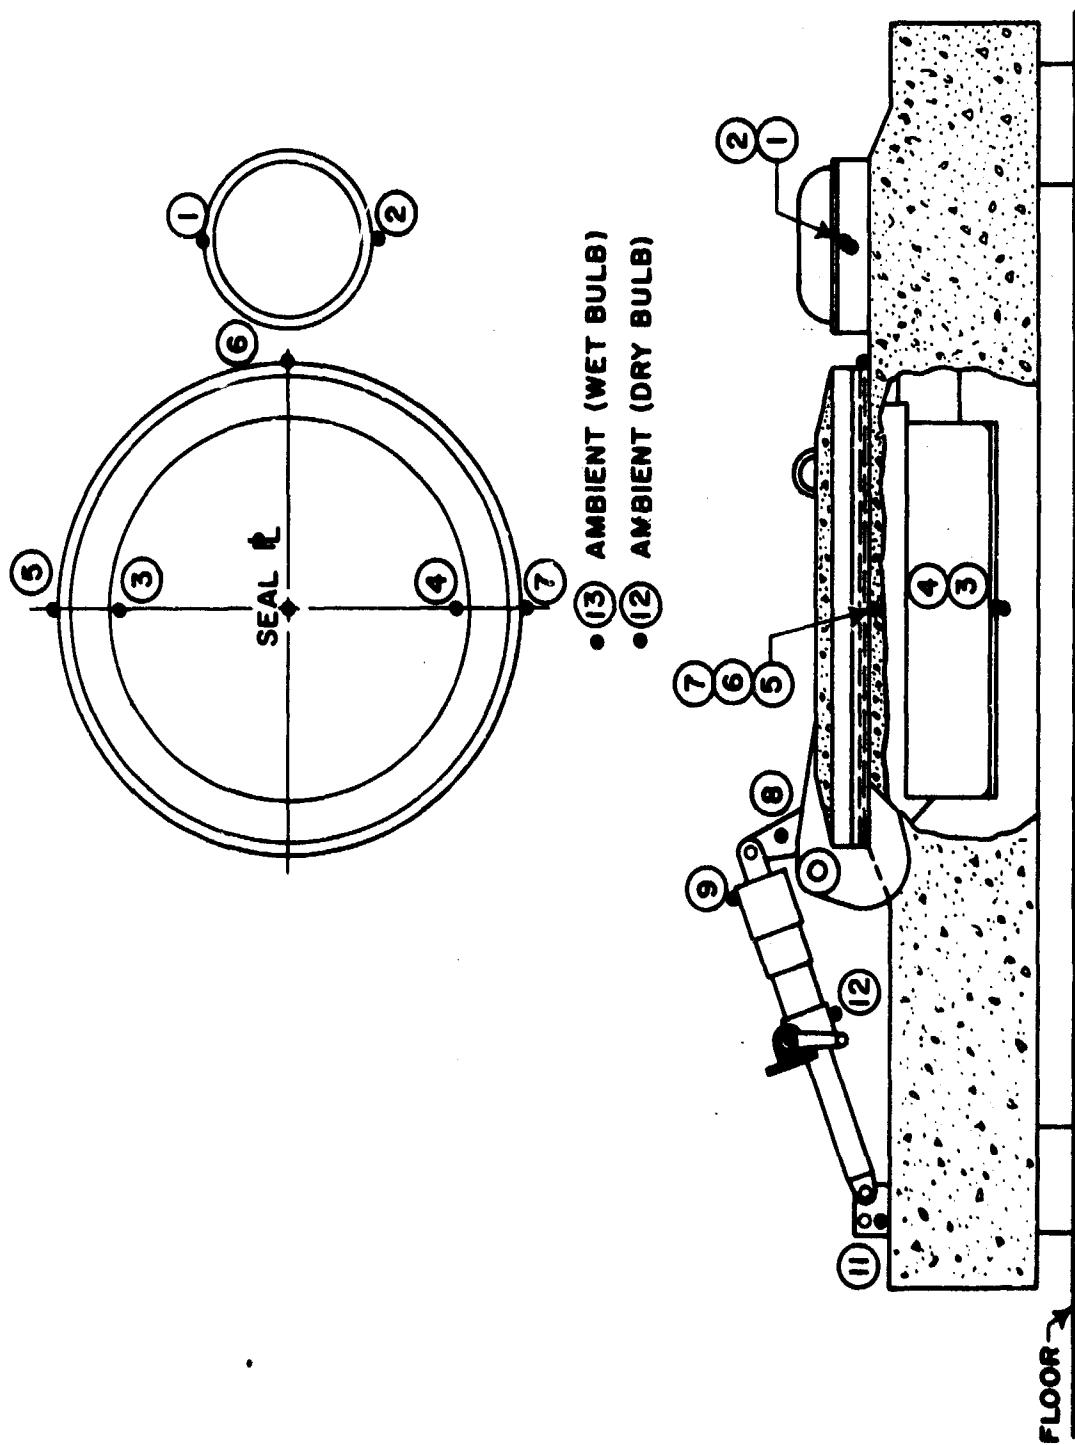
Figure 3. Personnel Access Hatch Thermocouple Locations

- c. The test item was placed in the environmental chamber and eleven specimen thermocouples, a dry-bulb thermocouple, and a wet-bulb thermocouple were installed as shown in figure 3.

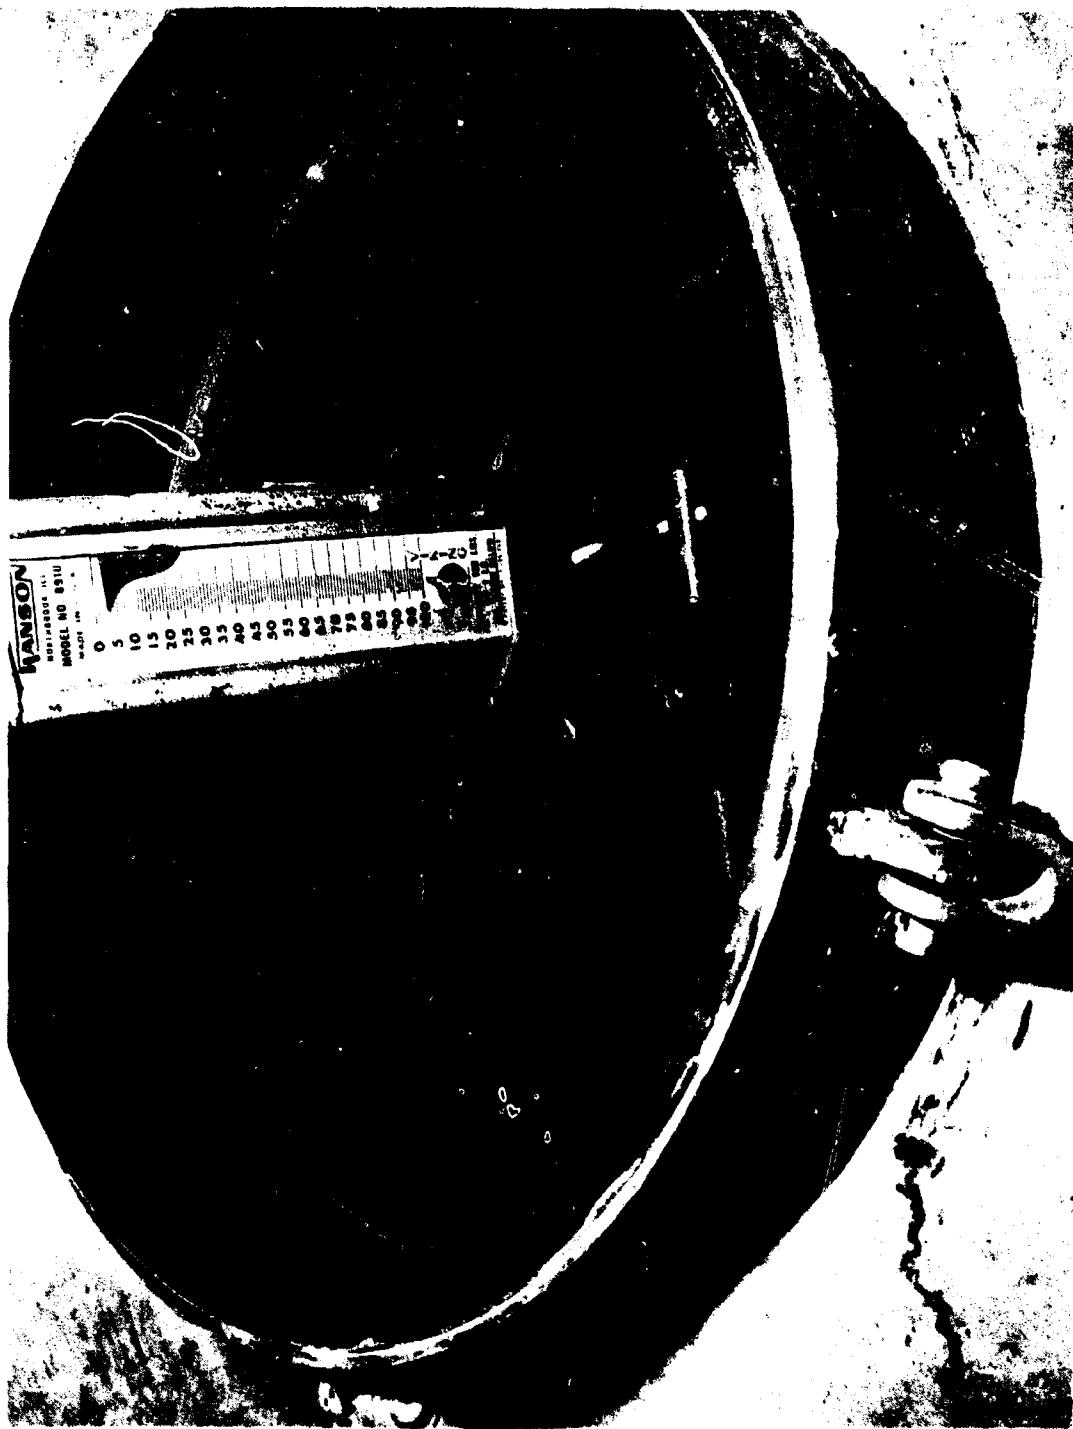
Figure 4. Locking Device with Calibrated Spring Scale Attached

- e. After reaching the desired temperature of 150°F, the test specimen was maintained at this temperature for a period of 8 hours.
- f. With the test specimen at 150°F, the operating torque of the locking device pin was measured using a calibrated spring scale, on a 3 1/2-inch lever arm attached to the operating handle as shown in figure 4.

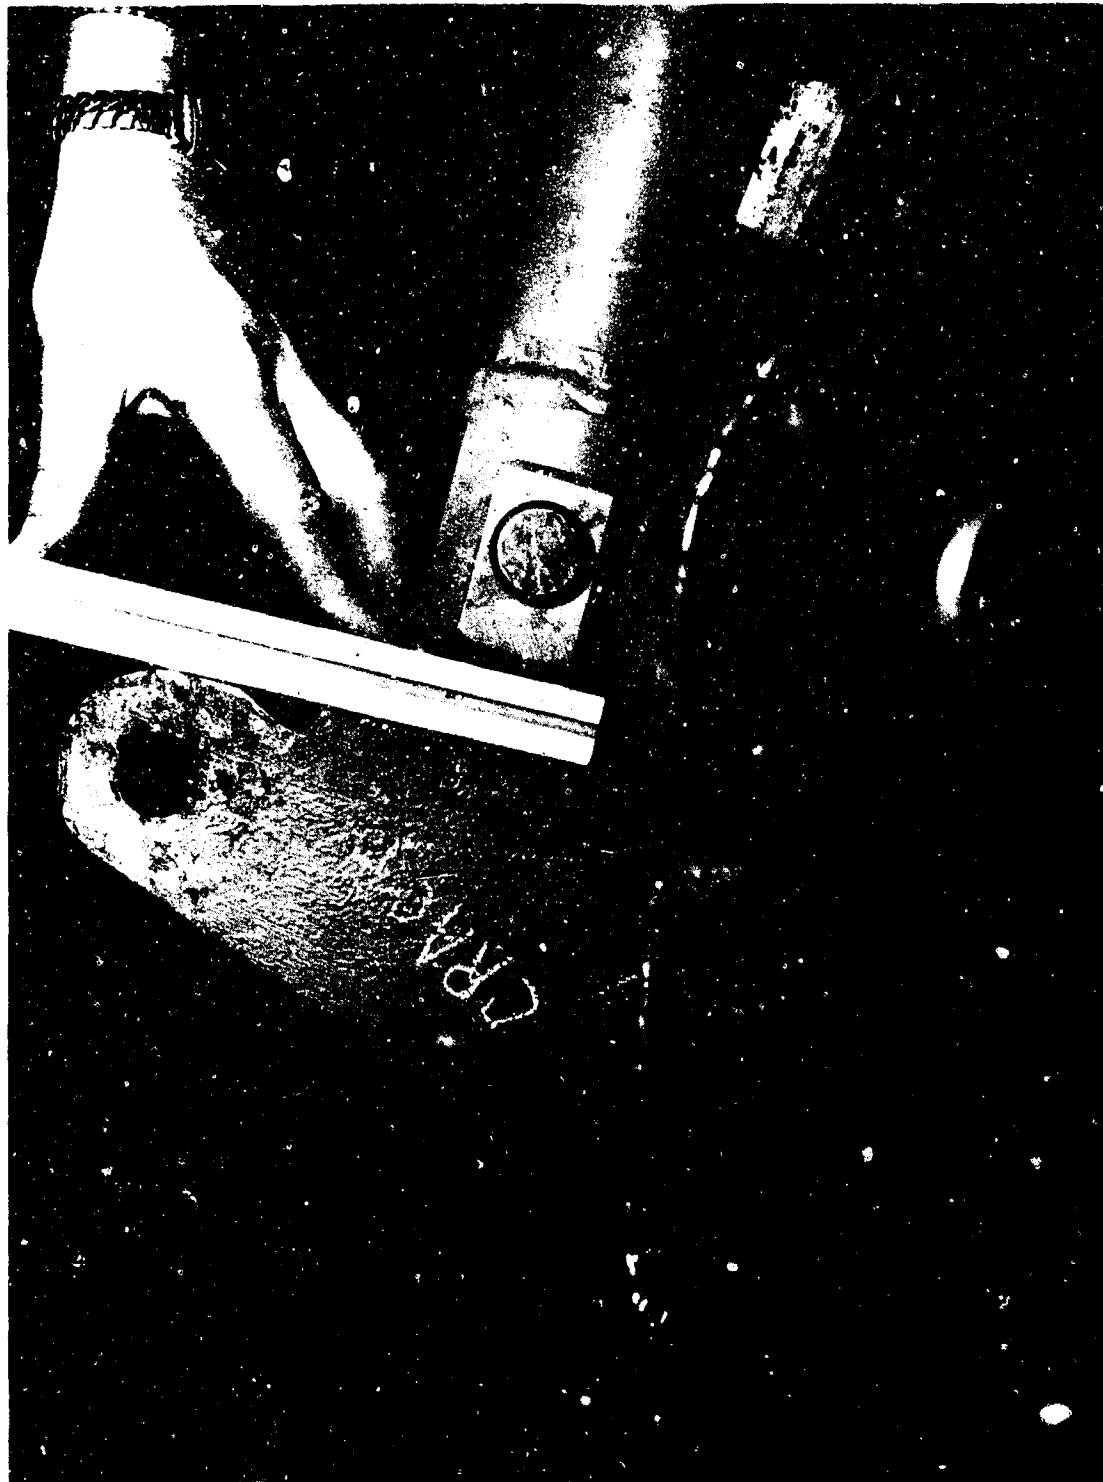
Figure 9. Hatch Arm Notching Measurements

(5) During installation of the actuator on the access hatch, interference was found between the actuator clevis throat and the attaching arm on the hatch cover. The attaching arm was notched as shown in figures 9 and 10 to permit installation of the actuator.

Figure 10. Hatch Arm Notching Detail

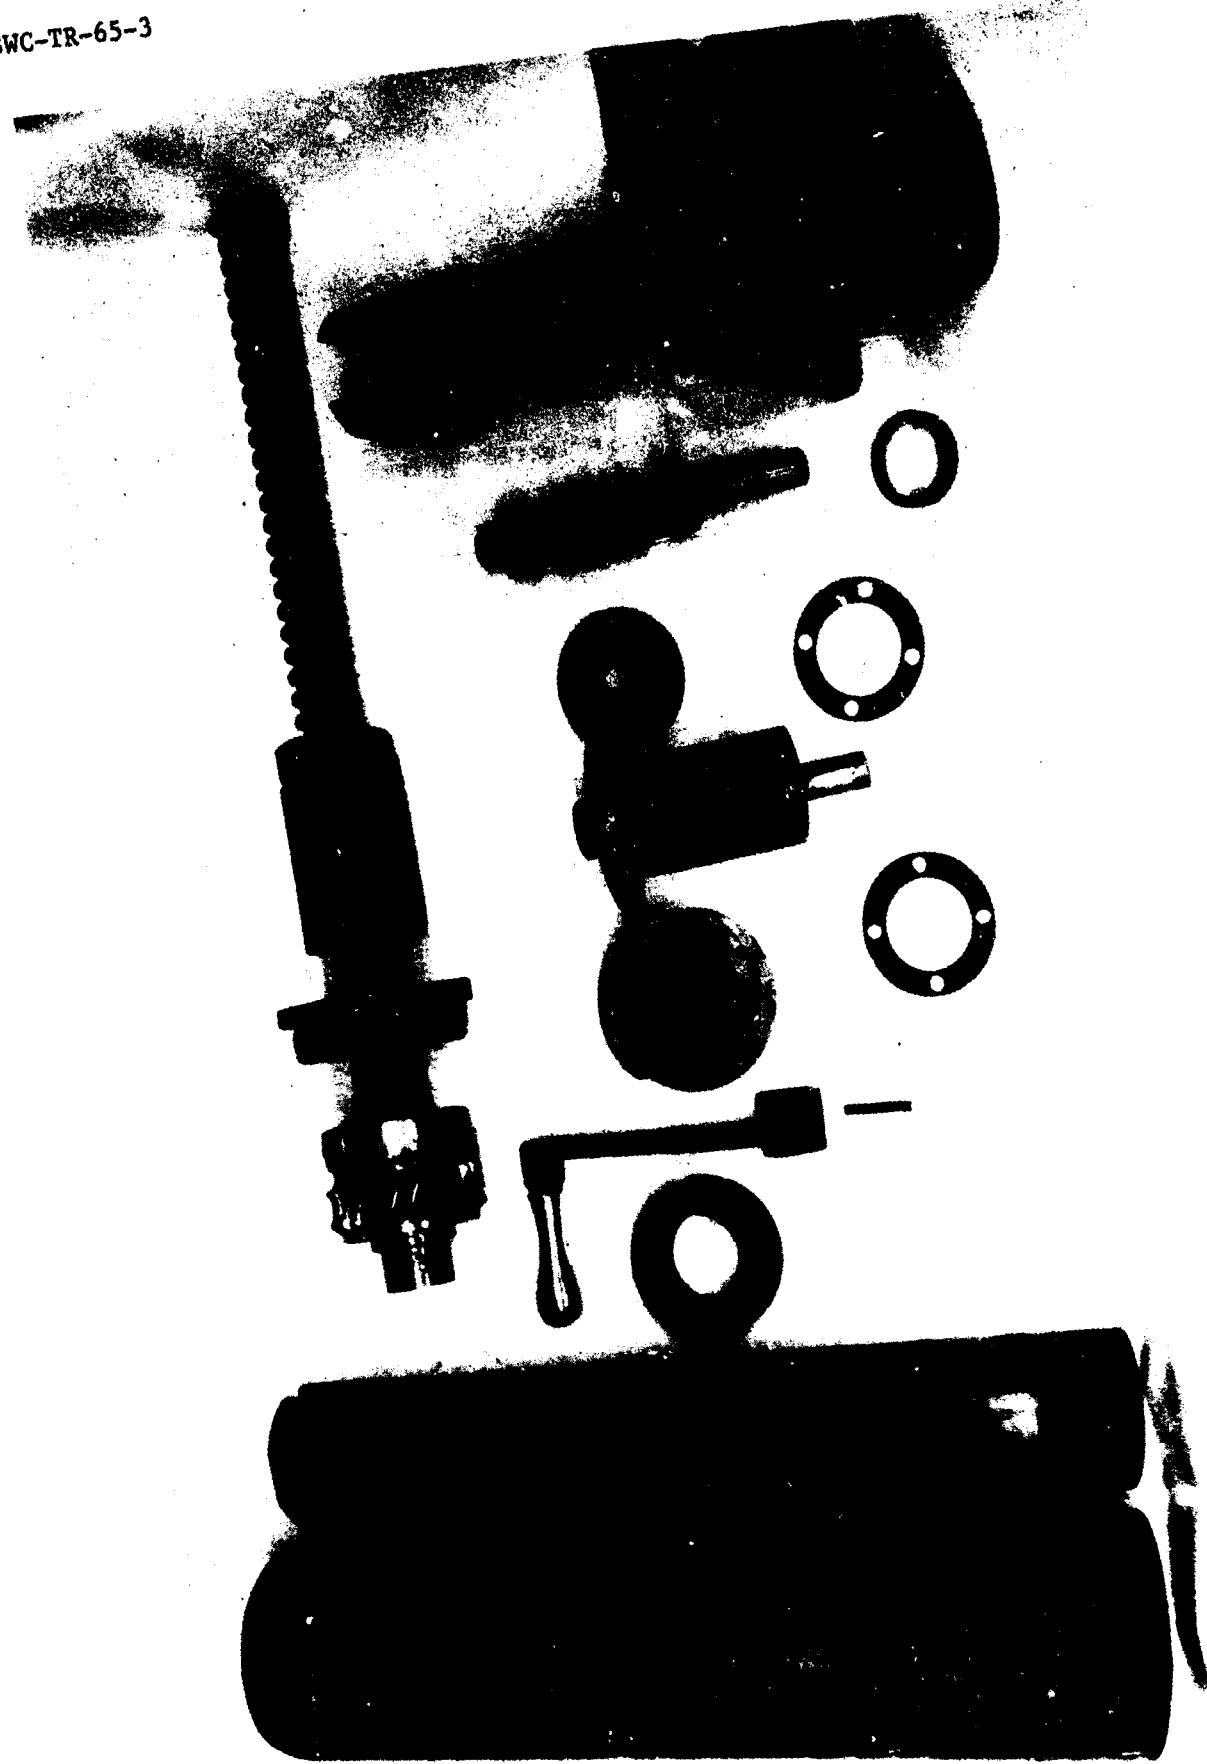
Figure 19. Disassembled Actuator

a. The Duff-Norton access hatch actuator was disassembled under the supervision of Mr. R. J. Beck, Chief Engineer, Duff-Norton Company. The disassembled actuator is shown in figure 19. Inspection revealed the following conditions:

(1) Some moisture was found in the outside tube indicating the joint between the outside tube and the shell cap does not seal effectively.

(2) No sand or dust penetration into the assembly was observed.

(3) The inside tube and its plated surface were in good condition except as noted in the pretest inspection.

(4) The wiper-scraper seal at the end of the outside tube had several local discontinuities in the scraper. These discontinuities were probably caused by actuator operation at the manufacturer's plant prior to removal of weld spatter from the inside tube plated surface, as noted in the pretest inspection.

(6) The ball screw and nut were in good condition, well lubricated, and showed no signs of excessive wear.

(7) The worm and gear were in good condition with no sign of wear.

(8) All anti-friction bearings were in good condition and functioned freely and smoothly.

(9) The oil leakage noted in the pretest inspection was apparently caused by limited disassociation of the base oil from the Molykote in the molybdenum-disulfide grease used to lubricate the actuator. This base oil escaped through the unsealed joint between the outside tube and the shell cap when the actuator was not installed and was resting horizontally. No detrimental effect to the actuator or its operation could be attributed to either the disassociation or leakage.

(11) The groove pin used to assemble the crank handle to the input shaft dropped out during validation and was replaced by a cotter pin. Inspection showed the holes for the groove pin in both the crank handle and the input shaft has been enlarged due to bearing pressure resulting from normal operating torques.
